348 Westmorland Avenue North, Toronto, Ontario

SUMMARY INSPECTION REPORT

INSPECTION REPORT

PROPERTY: 348 Westmorland Avenue North, Toronto, Ontario

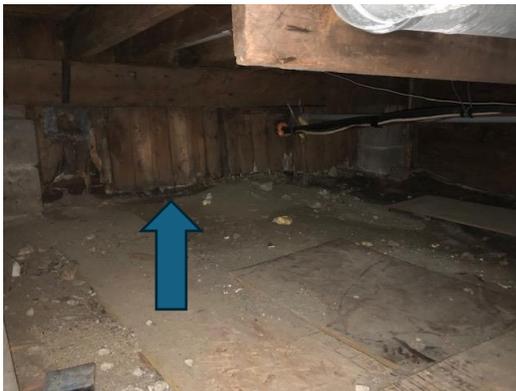
M: water seepage was noted through the base of west wall in the rear crawl space (wood skirting). The base of the wood skirting should be cut back on the west and south sides, and a concrete curb installed to eliminate any wood/soil contact, and to minimize the risk of leakage into the crawl space. Ensure that water drains away from the wood skirting on the exterior side. Water that gets into the crawl space presently drains below the soil and does not appear to impact the basement area.

P: ensure that water drains away from the west and south walls of the rear addition to prevent seepage into the crawl space area.

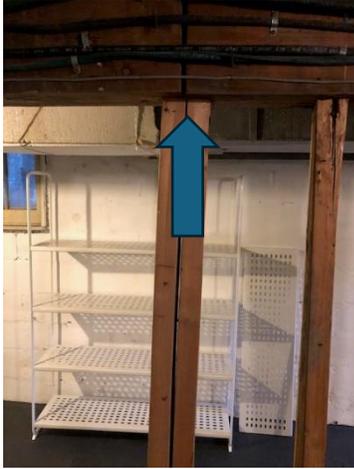
P: the wood framed wall in the middle of the basement supports two ends of the centre beam. One end needs to be re-supported on a proper steel post. A 2nd post is also needed near the furnace. It may be necessary to have proper concrete footings installed below the steel posts.

(Budget \$2,500)
